EXPERIMENTAL INVESTIGATION OF AIR-COOLED

TURBINE BLADES IN TURBOJET ENGINE

X - ENDURANCE EVALUATION OF SEVERAL

TUBE-FILLED ROTOR BLADES

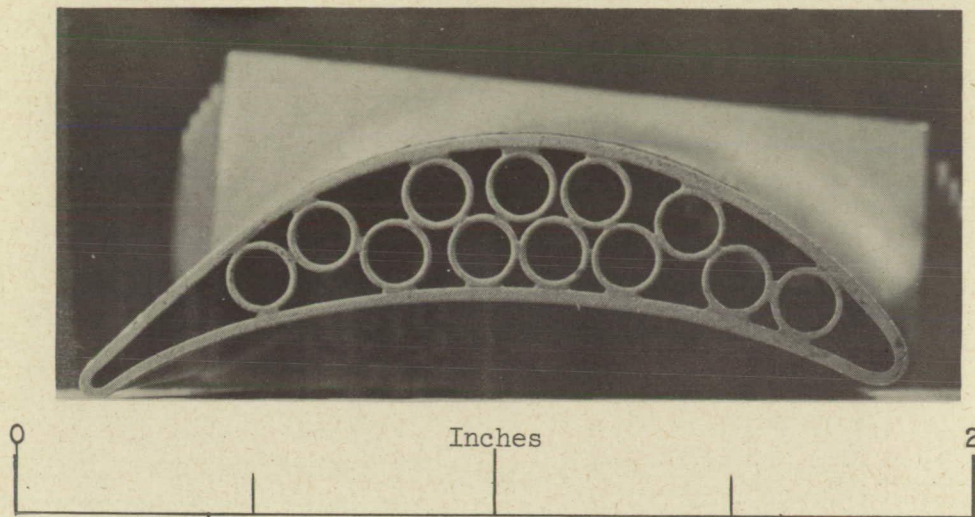
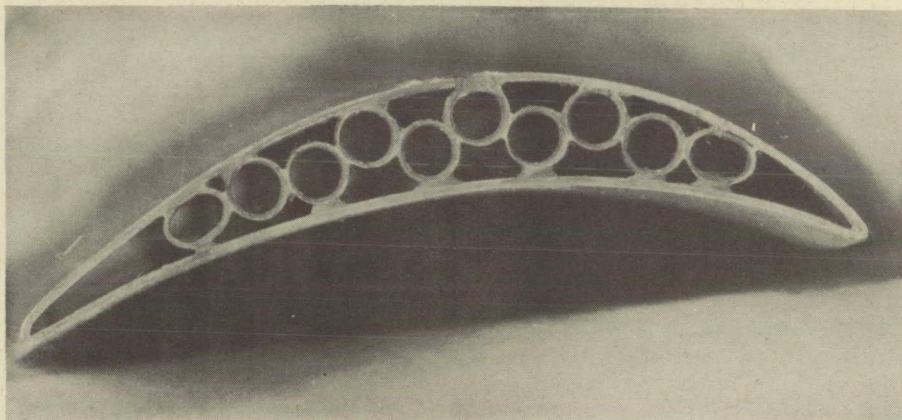
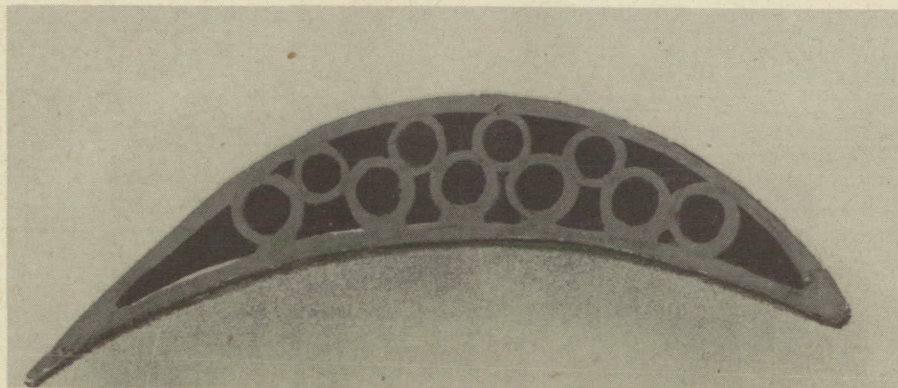
Figure 1. - Comparison of cross-sections of tube-filled blades with formed and cast shells.

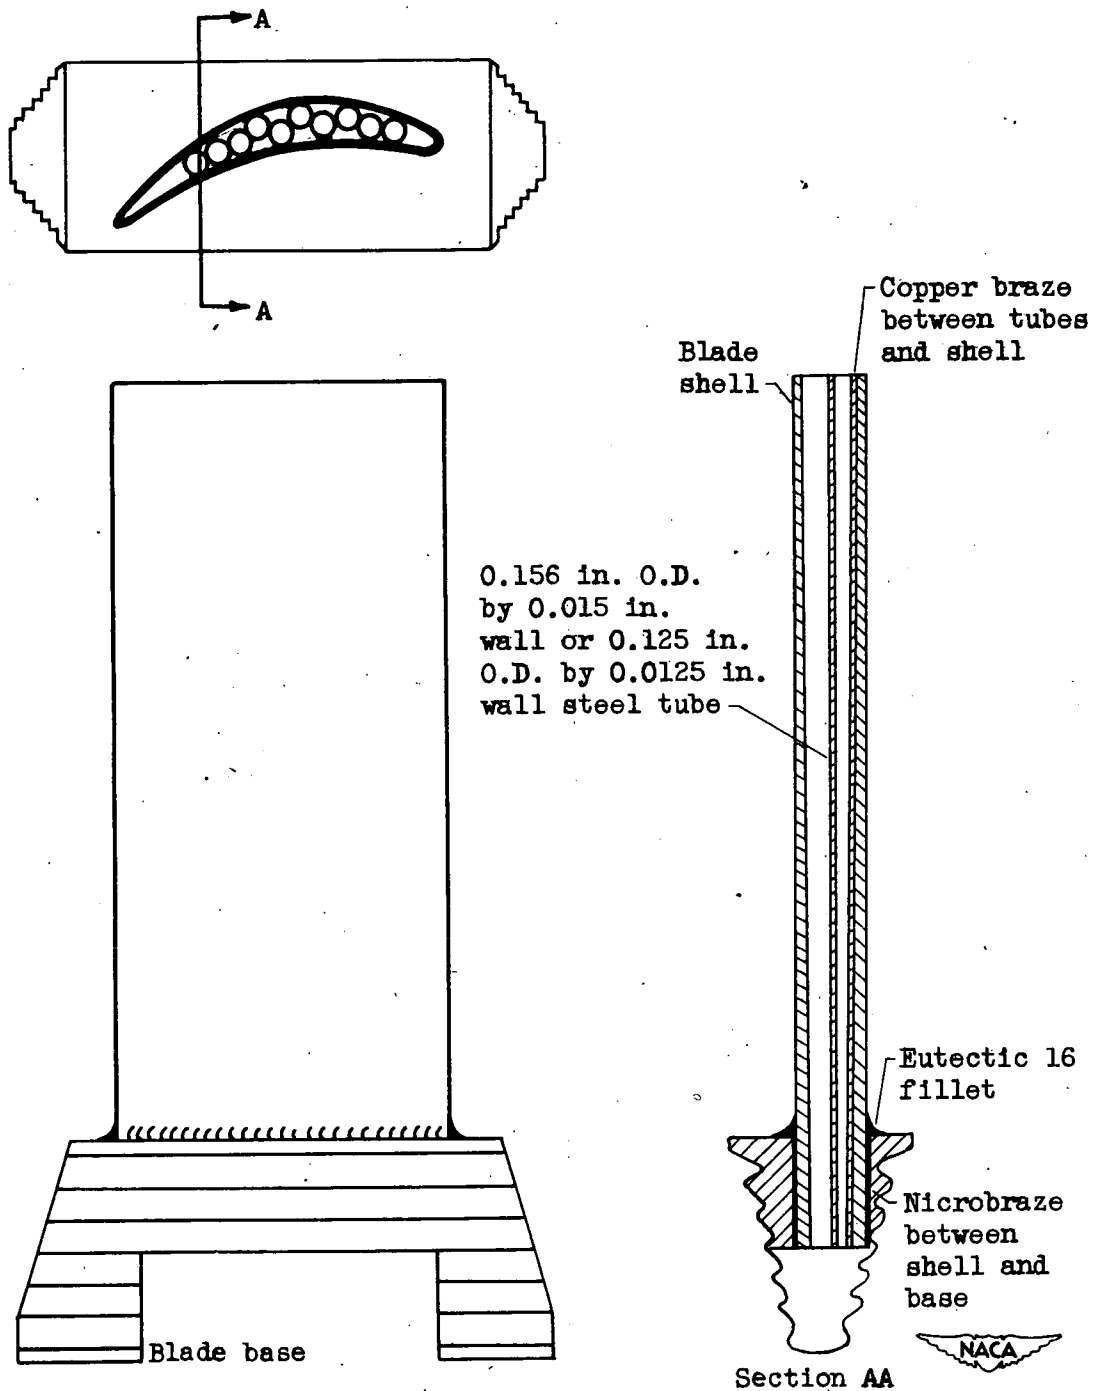
Figure 2. - Construction details of typical formed-shell blade utilizing brazed shell-to-base attachment.

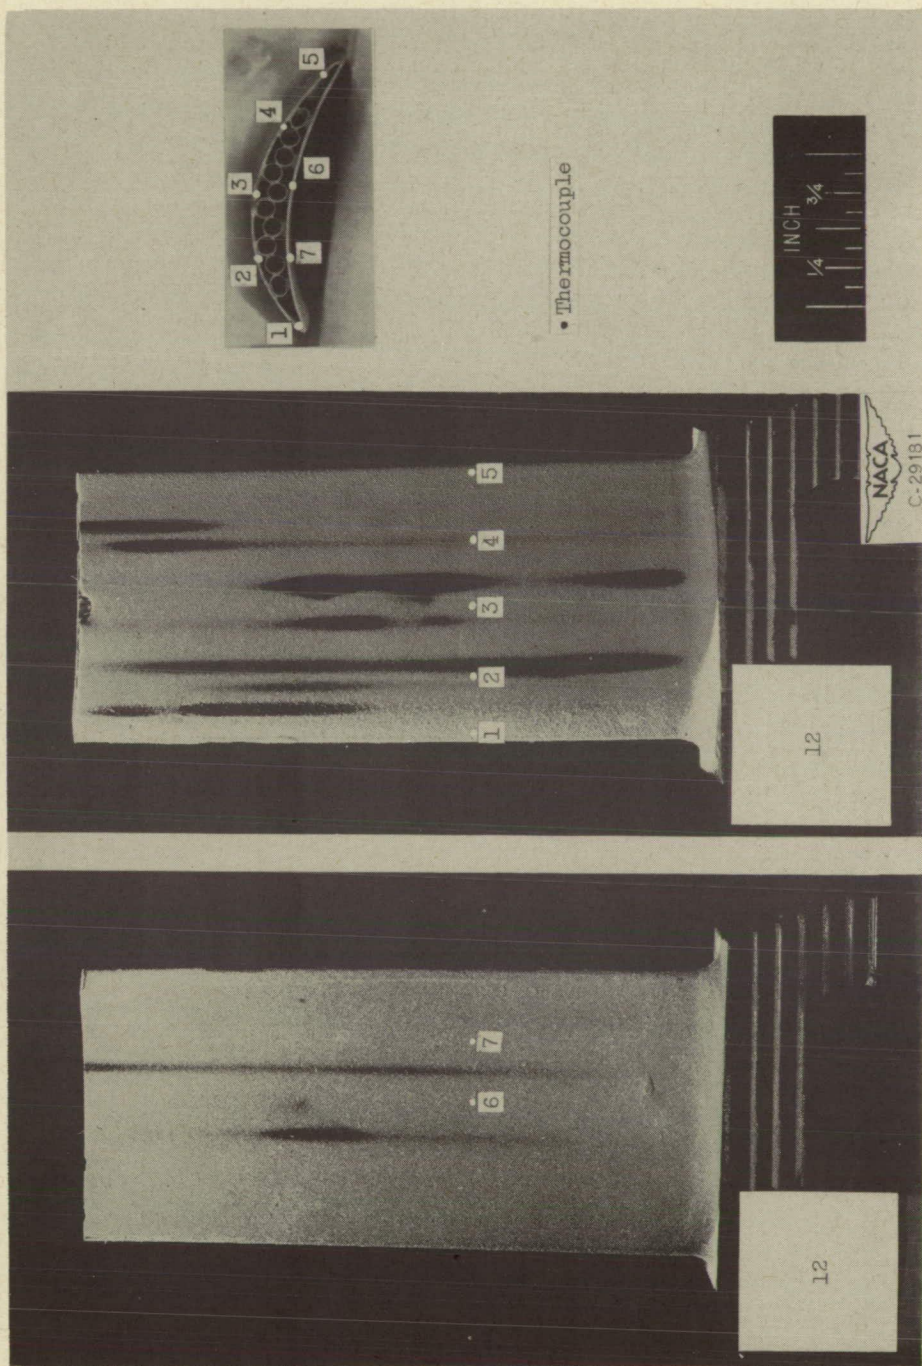
The quality of the braze between the tubes and the blade shell was checked on these blades by the following method: A temperature-indicating paint, Tempilaq, which melts at about 200° F was applied to the blade shell. Air at a temperature of approximately 1000° F was passed through each individual tube while the outside of the blade was cooled by air blowing over it. In the areas where there was a good thermal bond between the tube and the shell, the Tempilaq melted and caused a dark area (fig. 3). In the areas where there was a poor thermal bond between the tube and the shell, the paint was unaffected. In all blades tested there was poor bonding in some areas of the blade, particularly on the pressure surface. More research is required in the brazing technique for this type of blade construction.

Figure 3. - Location of thermocouples relative to areas showing good brazing between tubes and shell on blade 12.

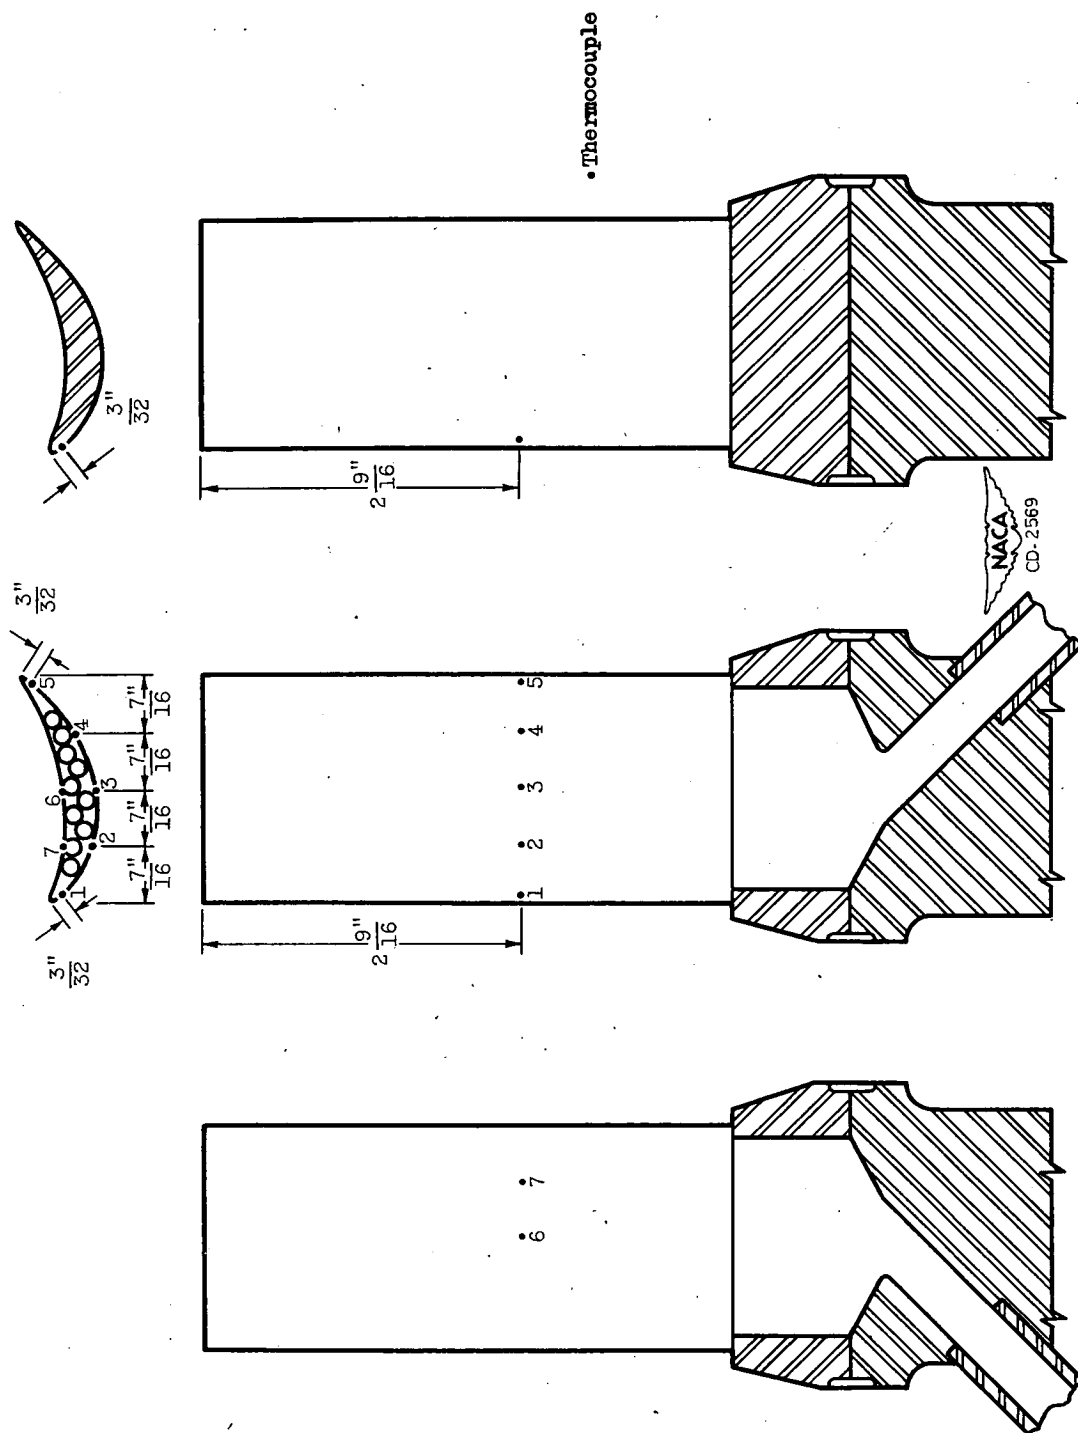
(a) Pressure surface of blade 12. (b) Suction surface of blade 12. (c) Uncooled reference blades.

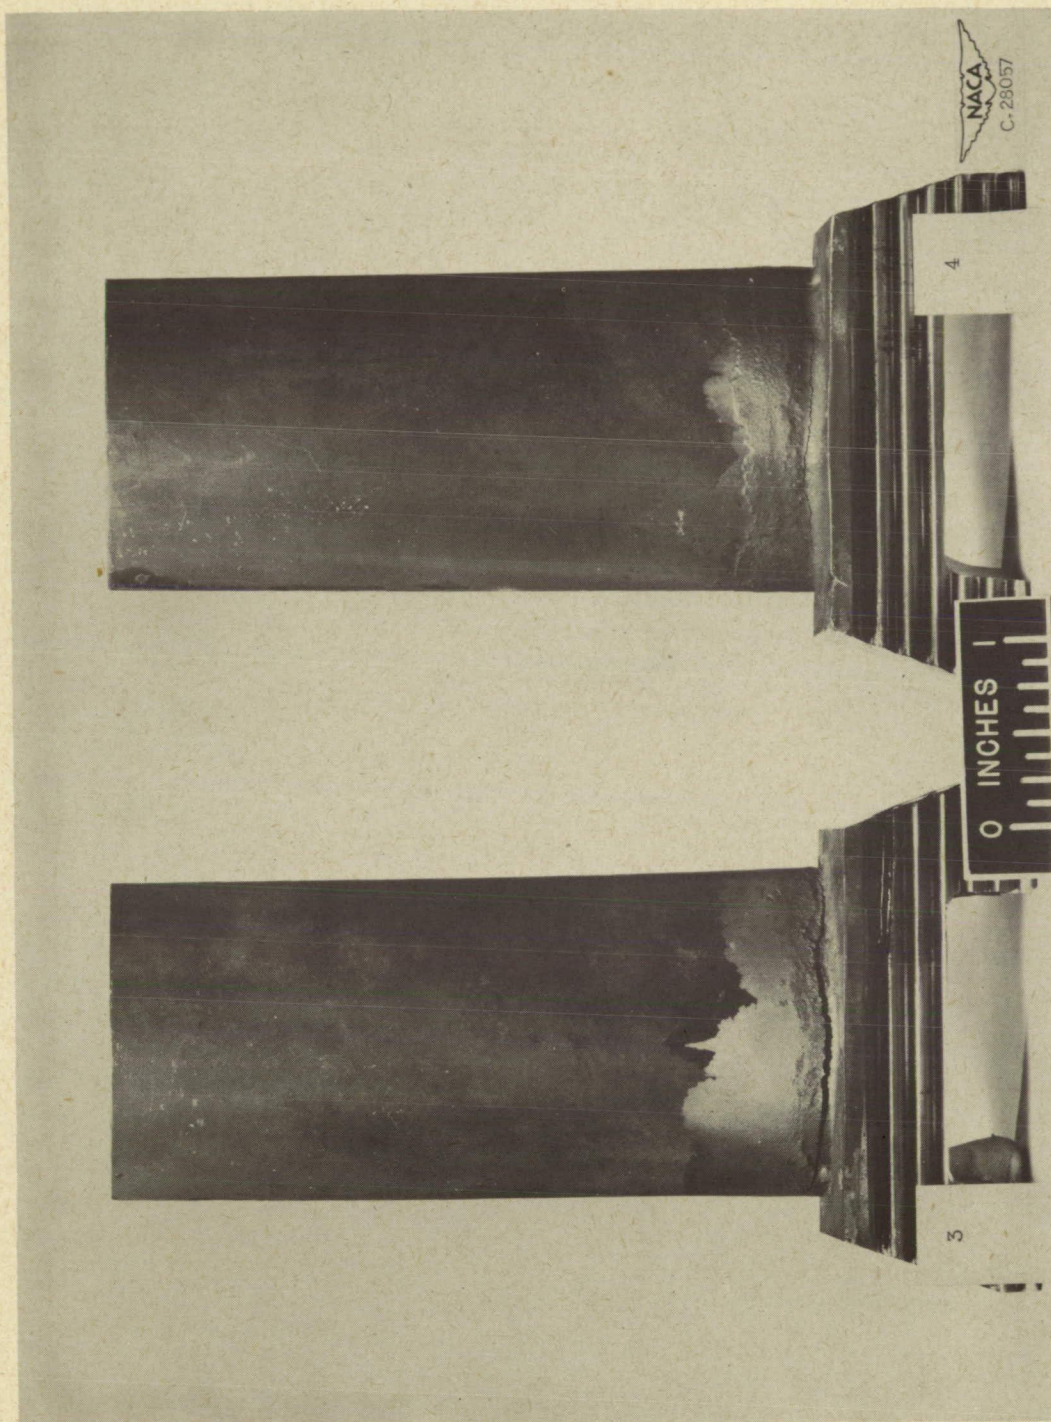
| Blade | Total time at 11,500 rpm and effective gas temperature of 1450° F | | | | Remarks |
|---|---|---|---|---|---|
| 3,4 | 2 | 0 | 1 | 0 | After 3 hr of constant-speed endurance cracks developed at root of each blade on suction surface as shown in fig. 5. Failures caused by lack of fillet at junction of shell and base. Braze shear stress, 3500 lb/sq in. |

Figure 5. - Blades 3 and 4 without fillet at junction of shell and base after 3 hours of rated-speed endurance test.

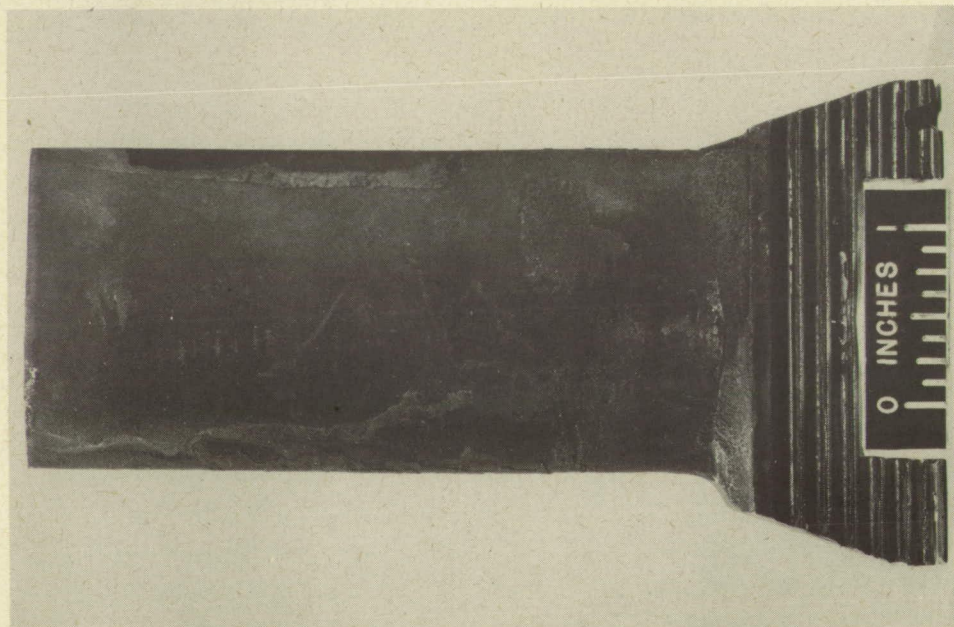
The durability of ceramic and nickel coatings for the purpose of reducing or eliminating oxidation of the low-alloy steel-blade shells was investigated in both constant-speed and cyclic-endurance investigations. Ceramic-coated blade 7 was endurance tested at cyclic conditions for 20 cycles at a coolant-flow ratio of 0.048 in order to determine the effect of heat shock on the coating, and then a constant-speed endurance test at a coolant-flow ratio of 0.048 was run until the coating failed.

(a) Blade 7. Coating chipped, particularly at leading and trailing edges, after  $7\frac{1}{4}$  hours of rated-speed endurance test.

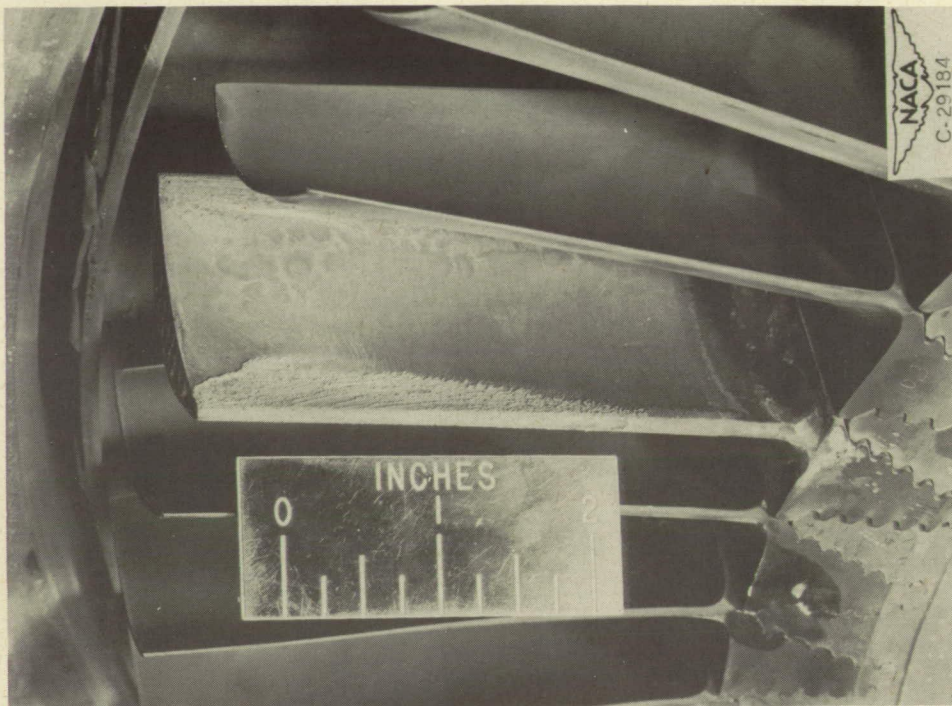
Ceramic-coated blade 8 was run at constant-speed endurance conditions at a coolant-flow ratio of 0.048 until the coating failed. A constant-speed endurance test was run because of less difficulty in conducting a constant-speed test and because no effect of cycling was observed on blade 7.

(b) Blade 8. Coating softened and flowed off of leading and trailing edges after  $4\frac{3}{4}$  hours of rated-speed endurance test.

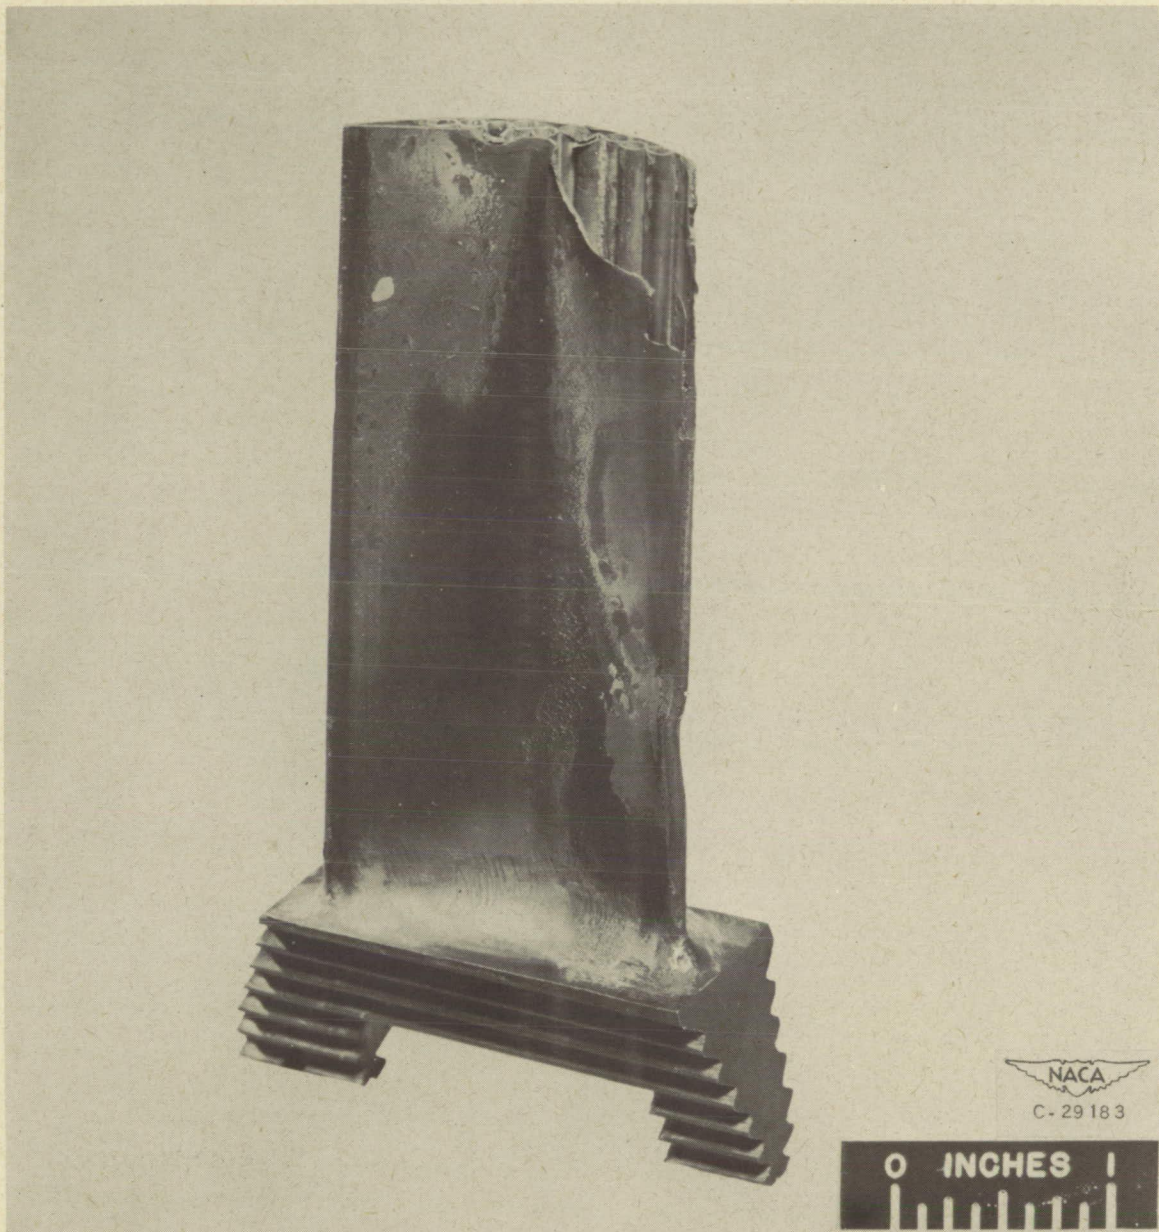
26 $\frac{1}{4}$  hours at a coolant-flow ratio of 0.03 and a total of 55 $\frac{1}{4}$  hours at rated speed on blade 12 (25 $\frac{1}{4}$  hr at 0.03 and 51 $\frac{1}{4}$  hr total on blade 14) a portion of the suction surface of blade 14 broke away near the blade tip as shown in figure 7. As discussed previously, blade 14 was not protected from oxidation by the nickel coating for the first 21 hours of the endurance investigation; therefore, rather severe oxidation and erosion at the leading edge occurred. In the area of the failure, the leading edge had oxidized until the metal thickness was almost zero and, in addition, in the same area there was no mechanical bond between the shell and the tubes in the coolant passage because of poor brazing. The piece of the blade broke off because of vibration. The endurance program was terminated at this point in order to instrument the remaining endurance blade (blade 12) and to determine the blade temperatures and stress-ratio factors that were encountered on this blade during the endurance investigation. Blade 12 was still in relatively good condition except for some oxidation at the leading edge of the blade (fig. 8). The dents that are evident near the blade tip on the suction surface and directly at the tip of the blade were the result of one of the standard uncooled-blade failures during the endurance test.

| Blade | Total time at 11,500 rpm and effective gas temperature of 1450° F | | | | | | | Remarks |
|---|---|---|---|---|---|---|---|---|
| 12 | 24 | 0 | 5 | 0 | 26 | 15 | A portion of blade 14 extending approximately 3/4 in. from the tip and 3/4 in. from the leading edge broke away from the pressure surface. Blade 12 was in good condition except for some oxidation at leading edge and the coating had scaled off in some areas. | |

Figure 7. - Blade 14 after a total of  $51\frac{1}{4}$  hours of rated-speed endurance test. Failure caused by vibration and erosion in area where there was poor brazing between tubes and shell.

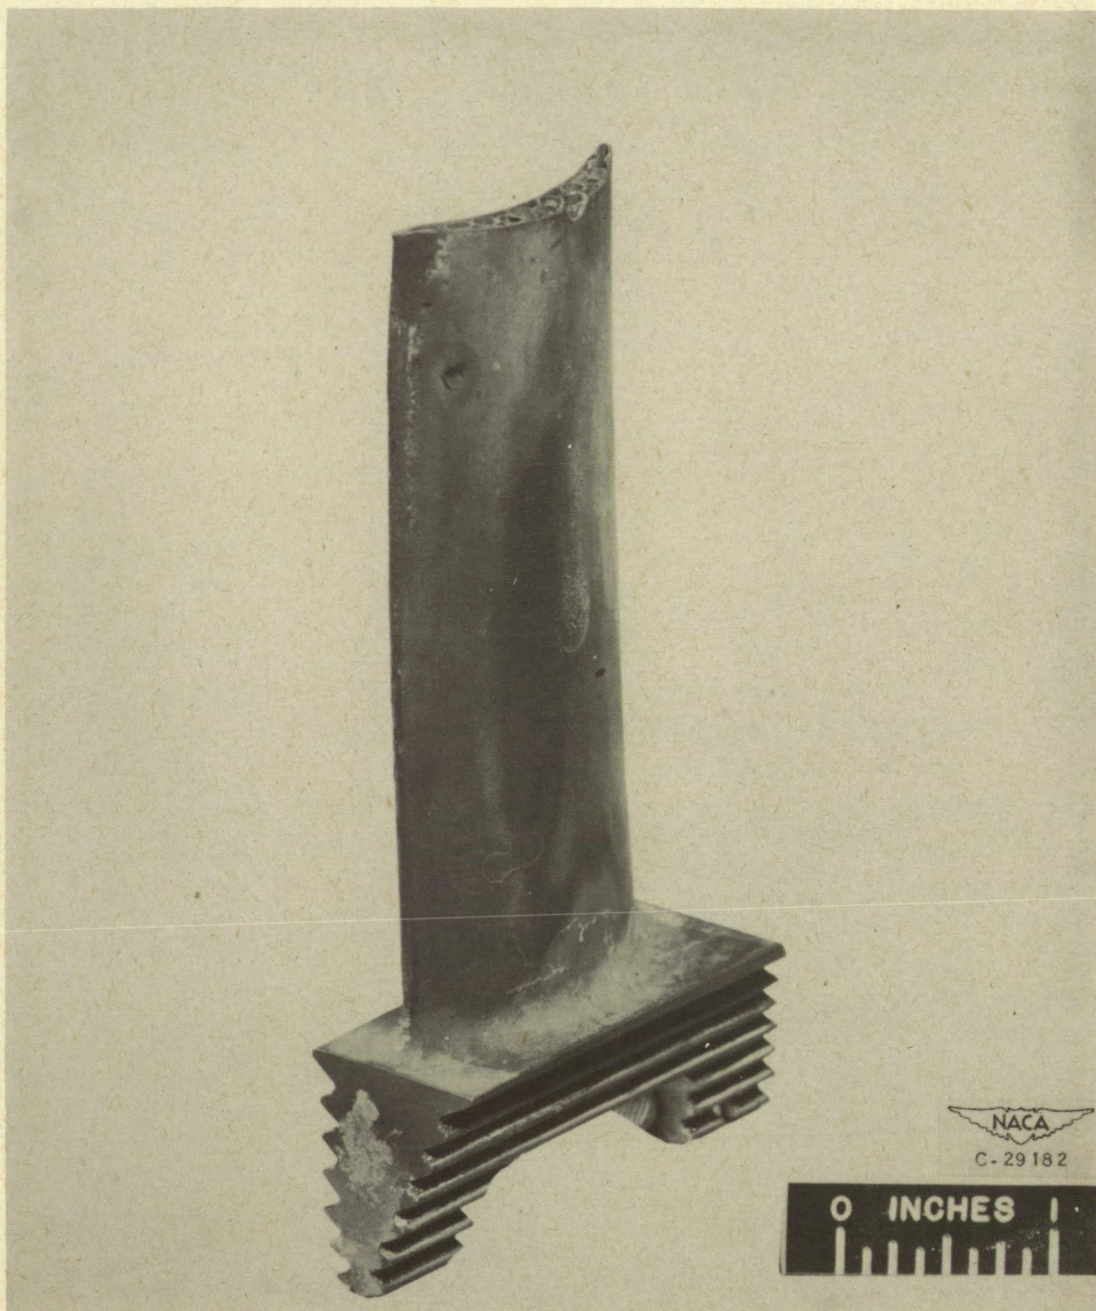
| Blade | Total time at 11,500 rpm and effective gas temperature of 1450° F | | | | | | | Remarks |
|---|---|---|---|---|---|---|---|---|
| 12 | 23 | 55 | 5 | 0 | 5 | 3 | Separation of shell from tubes at trailing edge tip on pressure surface due to poor brazing was observed. The nickel coating on blade 12 began to blister and scale on the pressure surface. | |

Figure 8. - Blade 12 after total of  $55\frac{1}{4}$  hours of rated-speed endurance test.

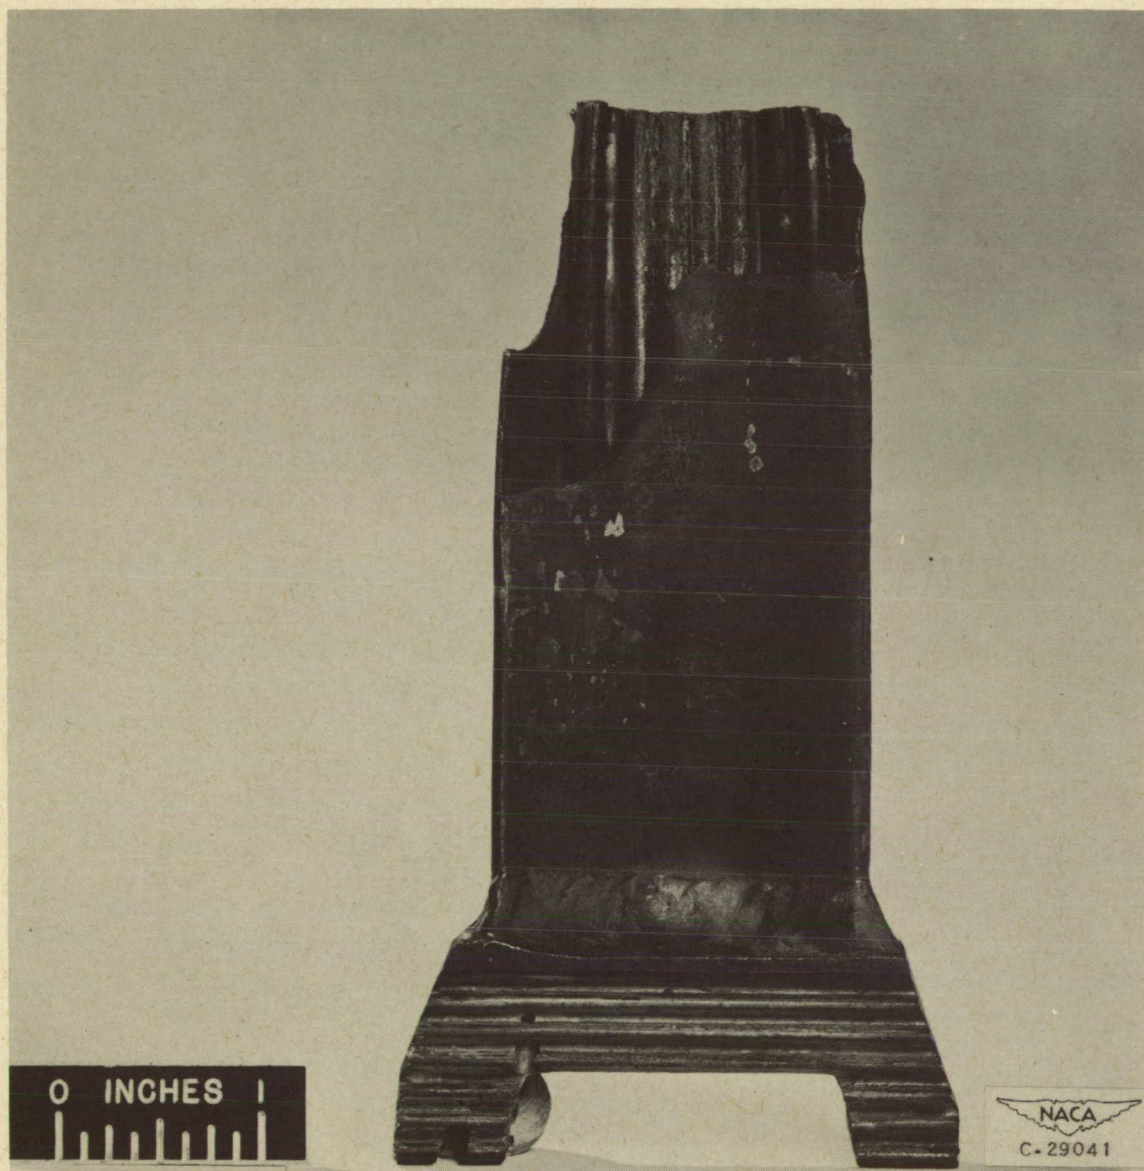
Timken alloy 17-22A(S) blade 9. - The Timken 17-22A(S) blade 9 was operated for two cycles without being heat-treated with no sign of elongation, but after the nonheat-treated SAE 4130 blade 10 elongated the 17-22A(S) blade was heat-treated. The blade then completed a total of 107 cycles ( $26\frac{3}{4}$  hr at rated speed) of which 5 cycles were run at a turbine-inlet temperature of approximately 1800° F, because of malfunctioning instrumentation; and the blade also withstood a few minutes of running with little or no cooling air at the same time the SAE 4130 blade 11 failed because of the air being cut off. The high-temperature running and the running with no cooling air apparently did not harm the blade. The blade probably was not completely uncooled at the time of the cooling-air failure. Cool air was still being supplied at the hub of the rotor and unpublished results obtained on other blades have indicated that enough air will be pumped through the cooling-air tubes on the turbine rotor by the turbine rotation to provide some cooling. This small amount of cooling evidently was sufficient to permit the blade to operate safely for the short period of time that it was run with the normal supply of cooling air cut off. It was not sufficient, however, to permit safe operation of blade 11, which was made of SAE 4130 steel. After 107 cycles the outer third of the pressure surface of blade 9 failed (fig. 9). This failure apparently was due to severe oxidation at the leading edge and a poor bond between the blade shell and the tubes in the coolant cavity. After failure at the leading edge due to oxidation, the shell apparently started vibrating and eventually a large portion of the shell broke off.

| Blade<br>(a) | Number<br>of<br>cycles | Total time at<br>rated speed | | Remarks |
|---|---|---|---|---|
| 9<br>6 | 107<br>46 | 26<br>11 | 45<br>30 | Outer third of pressure surface failed on blade 9 (fig. 7) because of oxidation and erosion of blade leading edge, poor bond between tubes and shell, and vibration. Test terminated. Blade 6 was in excellent condition except that the nickel coating was gone from leading and trailing edges and oxidation was starting. |

Figure 9. - Blade 9 after 107 cycles ( $26\frac{3}{4}$  hours at rated speed) of cyclic-endurance test at coolant-flow ratio of 0.03. Failure was caused by vibration, erosion, and poor braze between tubes and shell.

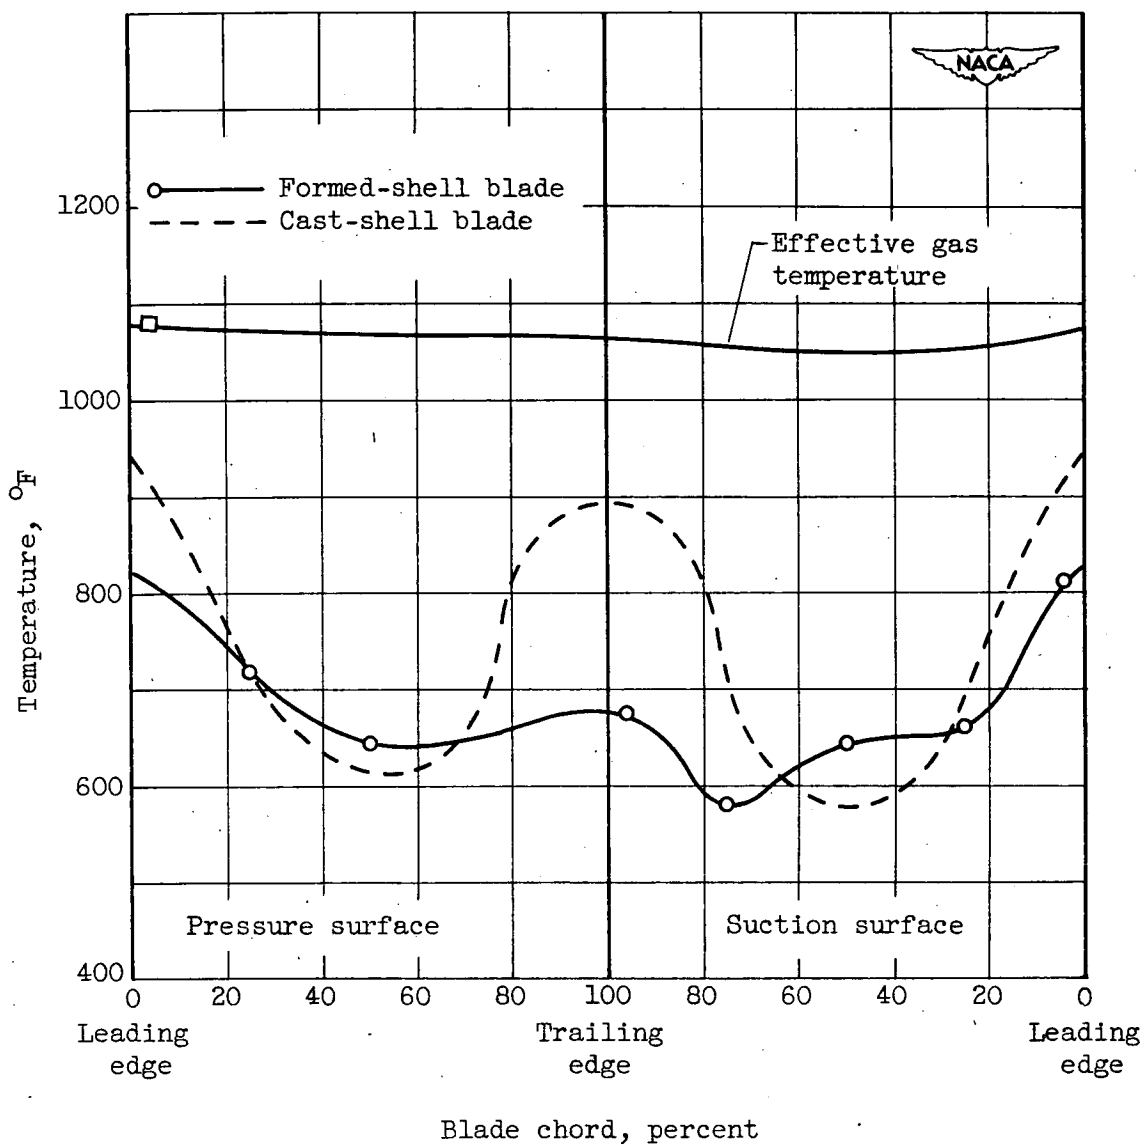
The temperature distributions of formed blade 12, utilizing a brazed shell-to-base type of construction, and the original cast tube-filled blade (reference 1) are shown in figure 10 for a coolant-flow

By noting the location of thermocouples on the blade relative to the areas on the blade where good thermal bonds were obtained between the tubes and the shell (fig. 3) it can be seen that thermocouple 3 at the 50-percent chord position on the suction surface and both thermocouples on the pressure surface of the blade are not in areas having a good thermal bond; the blade-shell temperatures would therefore be high. After developing better brazing techniques for the fabrication of tube-filled blades, the blades would be expected to cool more effectively on both the suction and pressure surfaces. Even with good brazing there would probably be small temperature gradients in the blade shell between adjacent tubes; however, these small gradients should have no significant effect on blade strength.

The solid-blade temperature, or effective gas temperature  $T_{g,e}$ , varies along the blade chord as shown in figure 10 because of the variations in the local Mach number along the blade as discussed in the TEST PROCEDURE section.

Figure 10. - Comparison of chordwise temperature distribution for cast-shell blade (reference 1) and formed-shell blade 12. Gas flow, 60.6 pounds per second (engine speed approximately 10,000 rpm); coolant-flow ratio, 0.029; cooling-air temperature at blade root, 133° F.

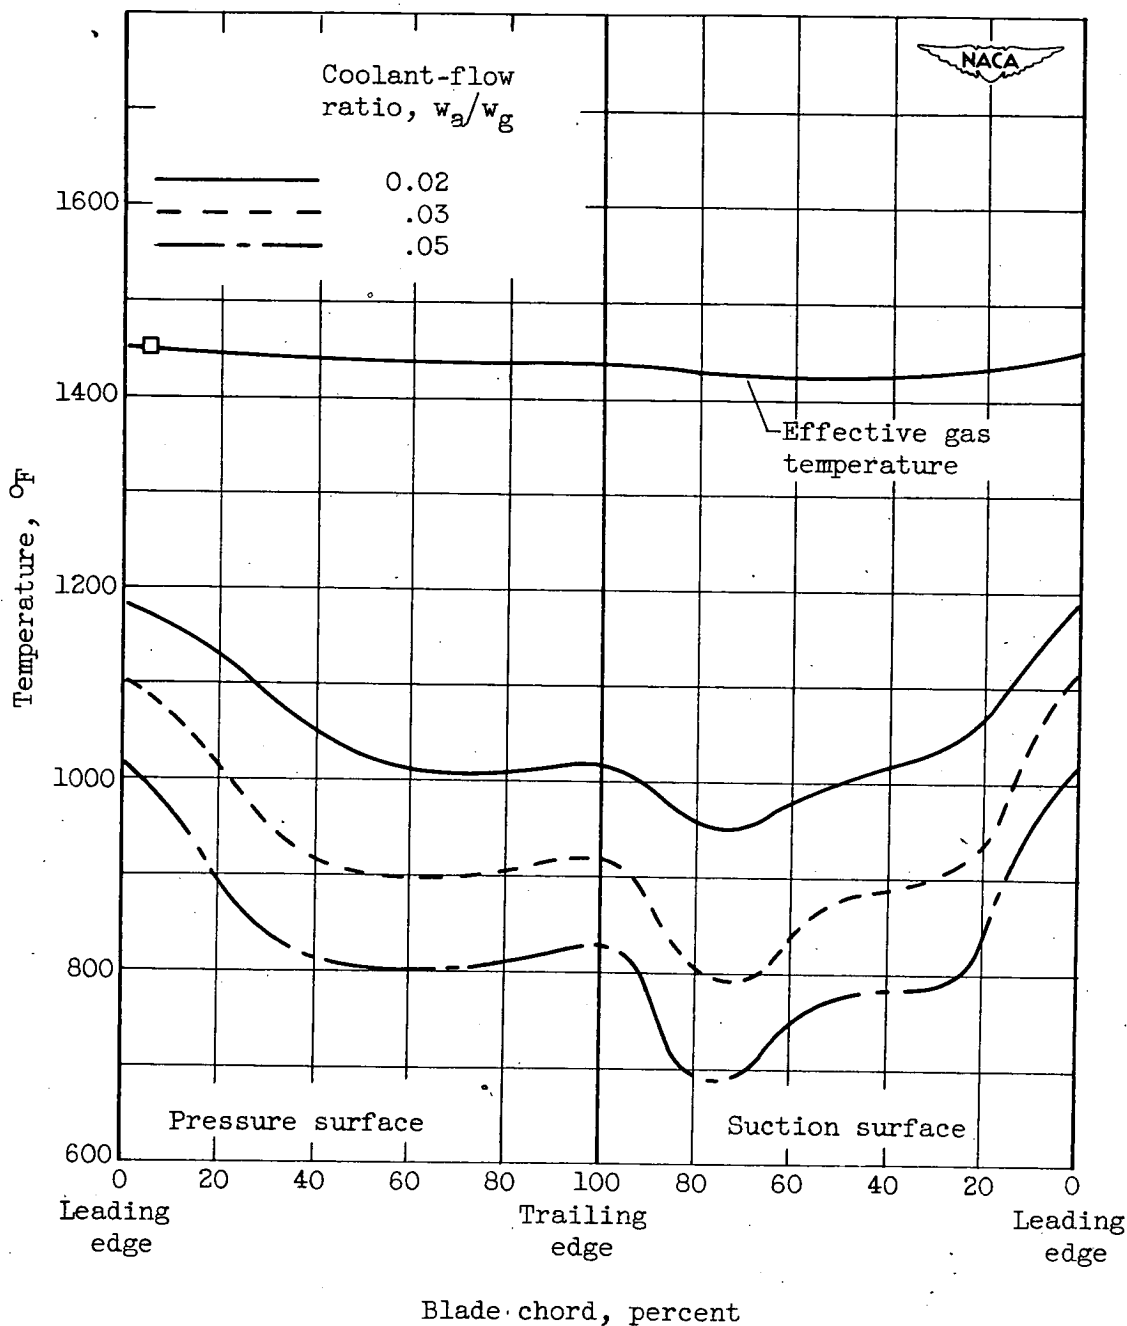
The blade temperatures at rated engine speed for coolant-flow ratios of 0.02, 0.03, and 0.05 are shown in figure 11. These curves were obtained from cross plots of temperature data shown in table V. The fact that it was possible to run a blade containing seven thermocouples at these engine conditions and at a coolant-flow ratio as low as 0.02 is a good indication of the high blade-cooling effectiveness.

Figure 11. - Blade 12 temperature distributions for three coolant-flow ratios at rated engine speed of 11,500 rpm. Cooling-air temperature, 180° F.

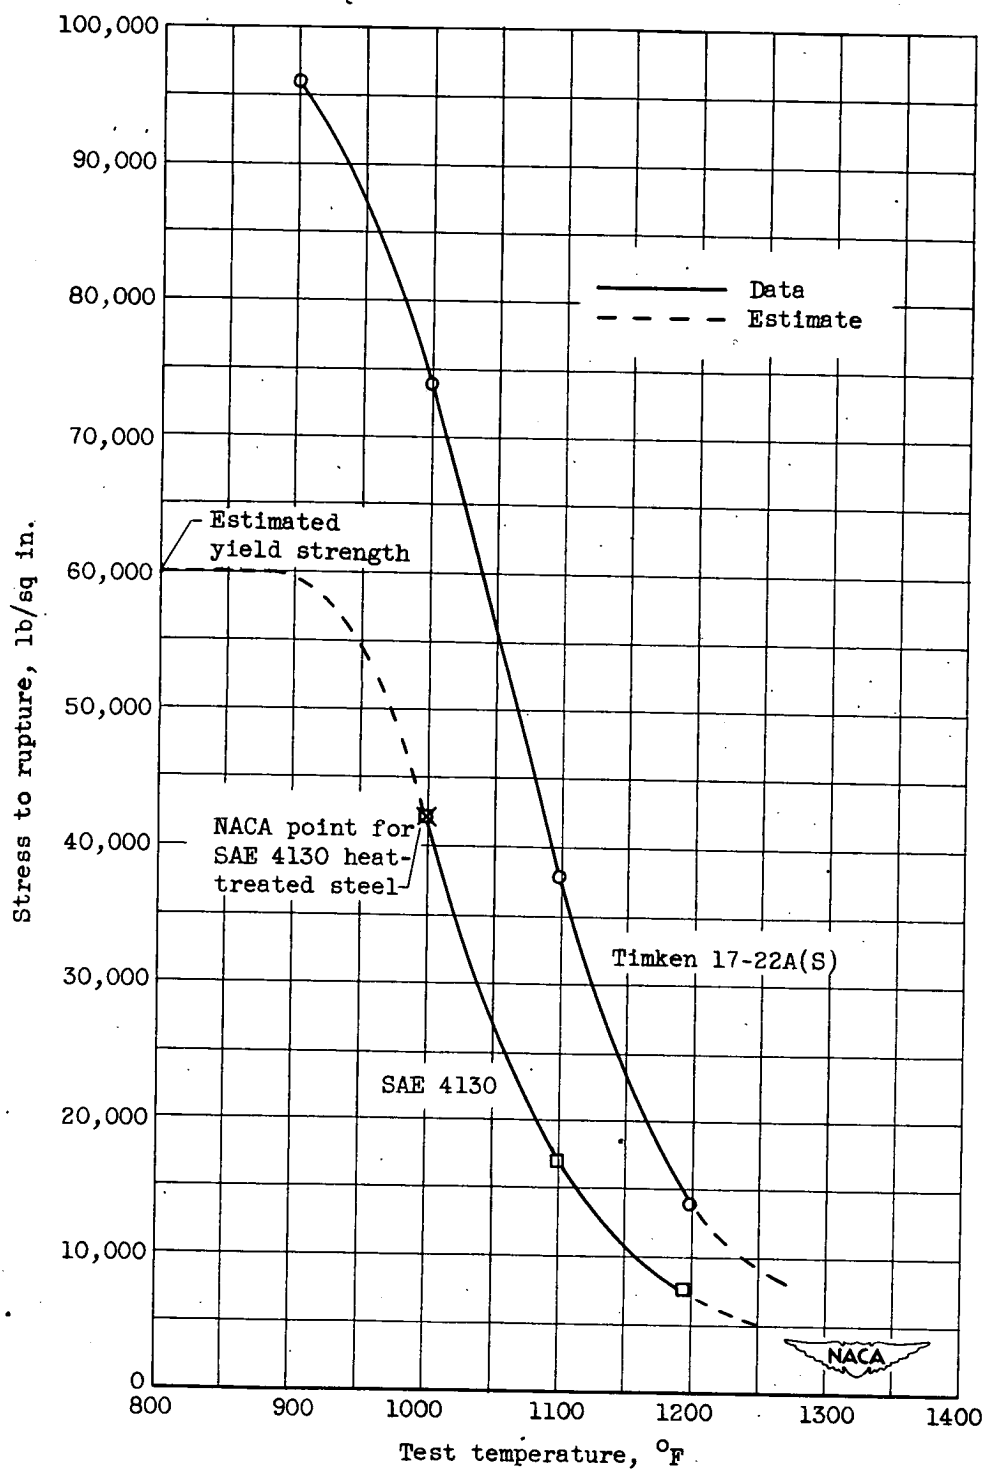
In figure 12 are shown 100-hour stress-rupture curves for SAE 4130 and Timken 17-22A(S) low-alloy steels. The Timken 17-22A(S) curve was obtained from unpublished data for samples that were normalized at  $1725^{\circ}\text{F}$  and drawn for 6 hours at  $1200^{\circ}\text{F}$  and then air cooled. The portion of the SAE 4130 curve represented by the solid line with the three data

Figure 12. - Stress-rupture curves of 100 hours for heat-treated SAE 4130 and Timken 17-22A(S) low-alloy steels. Curve for SAE 4130 estimated from data obtained from a metal of similar composition.

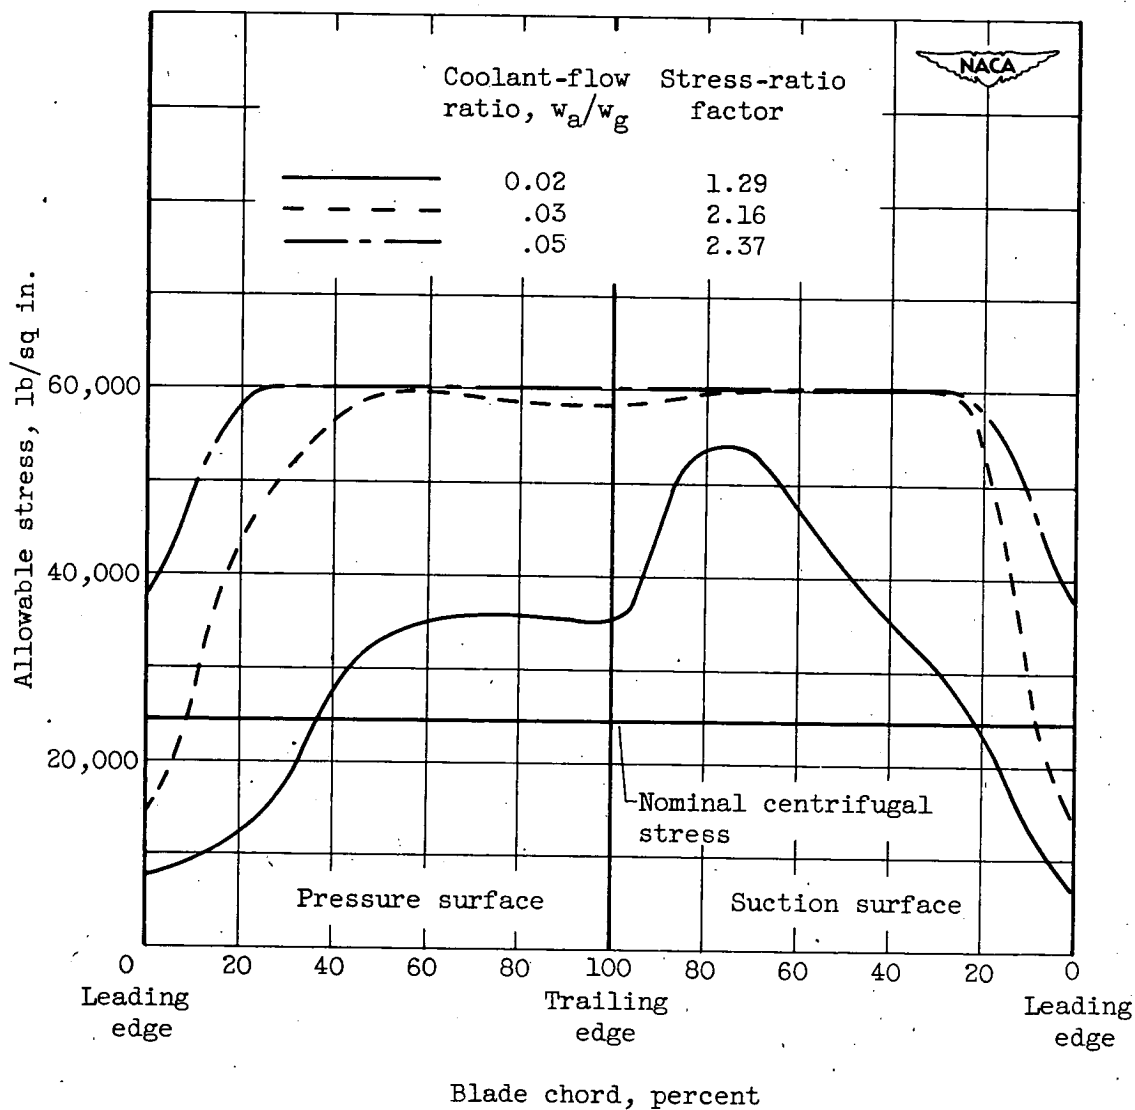
The allowable stress-distribution curves for blade 12 operating at an effective gas temperature of 1450° F and rated engine speed with a cooling-air temperature of 180° F are shown in figure 13 for coolant-flow ratios of 0.02, 0.03, and 0.05. Figure 13 was obtained from the temperature distributions in figure 11 and the SAE 4130 stress-rupture curve in figure 12. When the ratio of the area under the allowable stress curve to the area under the nominal centrifugal stress curve is taken, stress-ratio factors of 1.29, 2.16, and 2.37 result for coolant-flow ratios of 0.02, 0.03, and 0.05, respectively. These stress-ratio factors were obtained for one of the blades that was endurance tested. Based on the SAE 4130 stress-rupture curve (fig. 12) the tube-filled rotor blades of the type investigated are capable of safe operation at stress-ratio factors of 2.16 or less. The minimum stress-ratio factor will have to be determined by further experimentation; however, an indication of the safety of lower stress ratio factors can be obtained from the fact that blade 12 was able to operate at a coolant-flow ratio of 0.02, which resulted in a stress-ratio factor of 1.29 even though seven thermocouples were buried in the blade shell.

Figure 13. - Allowable stress distributions for blade 12 for three coolant-flow ratios at rated engine speed. Effective gas temperature, 1450° F; cooling-air temperature, 180° F; blade material, SAE 4130 steel.

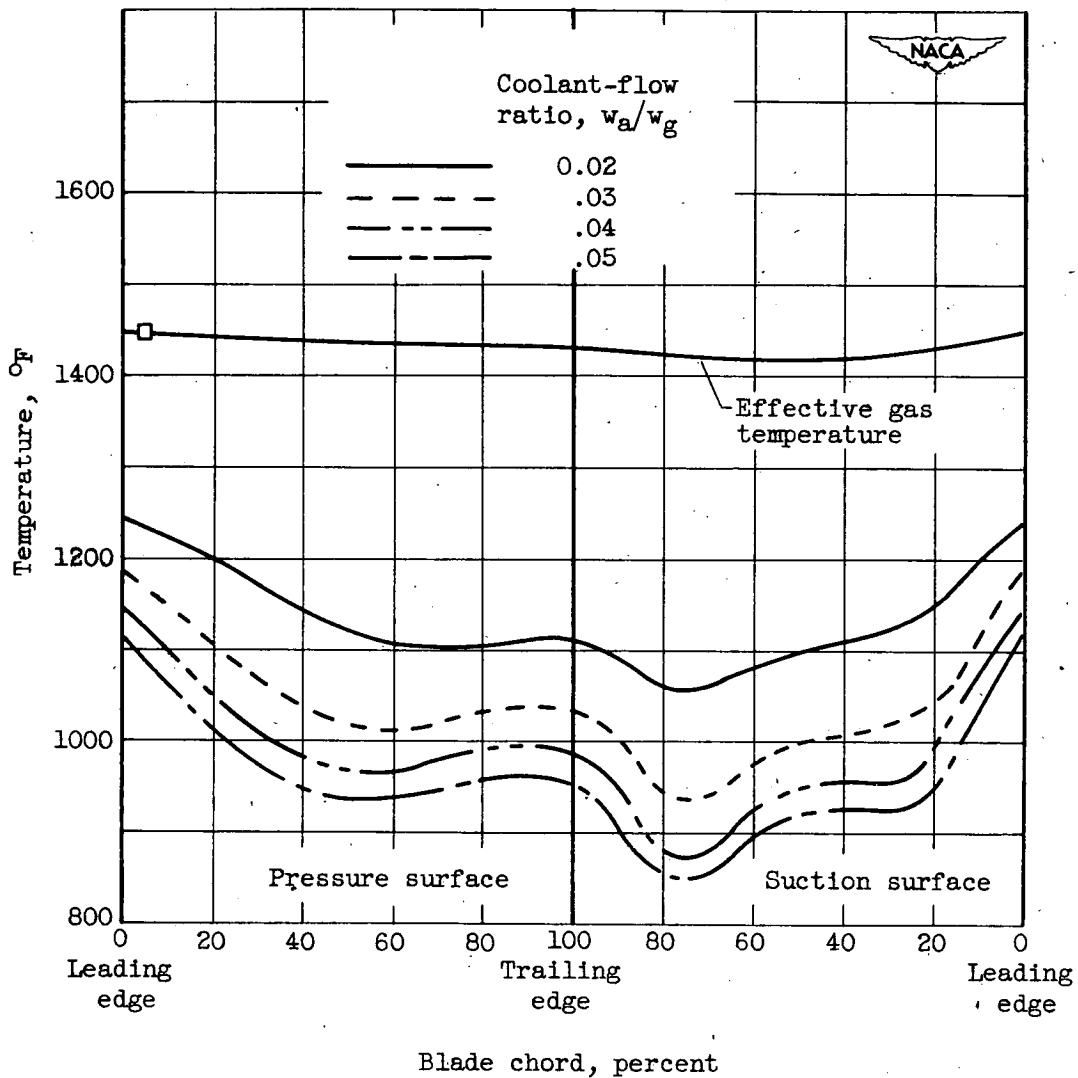
The effect of blade material on coolant-flow requirements can be illustrated very effectively by the use of the stress-ratio factor. In figure 14 the blade-temperature distributions that could be expected for

the improved type of formed blade (blade 12) for the case where the cooling air was bled from the compressor are shown. This curve was obtained from the data in table V using a cooling-air temperature of 450° F. From figure 14 and the stress-rupture curves in figure 12 the stress-ratio factors for blades made of Timken alloy 17-22A(S) and SAE 4130 can be obtained as explained in the section PROPOSED CRITERION FOR EVALUATING AIR-COOLED TURBINE BLADES in order to obtain a plot of stress-ratio factor against coolant-flow ratio as shown in figure 15. The great reduction in coolant flow required for the Timken 17-22A(S) steel blade is obvious. For a stress-ratio factor of 2.0, the quantity of cooling air required for the Timken 17-22A(S) blade is about 55 percent of that required for the SAE 4130 blade. The difference in critical alloy content in the two metals is insignificant. Figure 15 illustrates the very great gains that can be obtained by use of proper selection of blade materials and, in addition, sheds additional light on the superior performance of Timken 17-22A(S) blade 9 over SAE 4130 blades 10 and 11 in the cyclic-endurance investigation.

Figure 14. - Predicted temperature distributions for blade 12 with cooling air bled from compressor at rated engine speed. Cooling-air temperature,  $450^{\circ}\text{F}$ .
